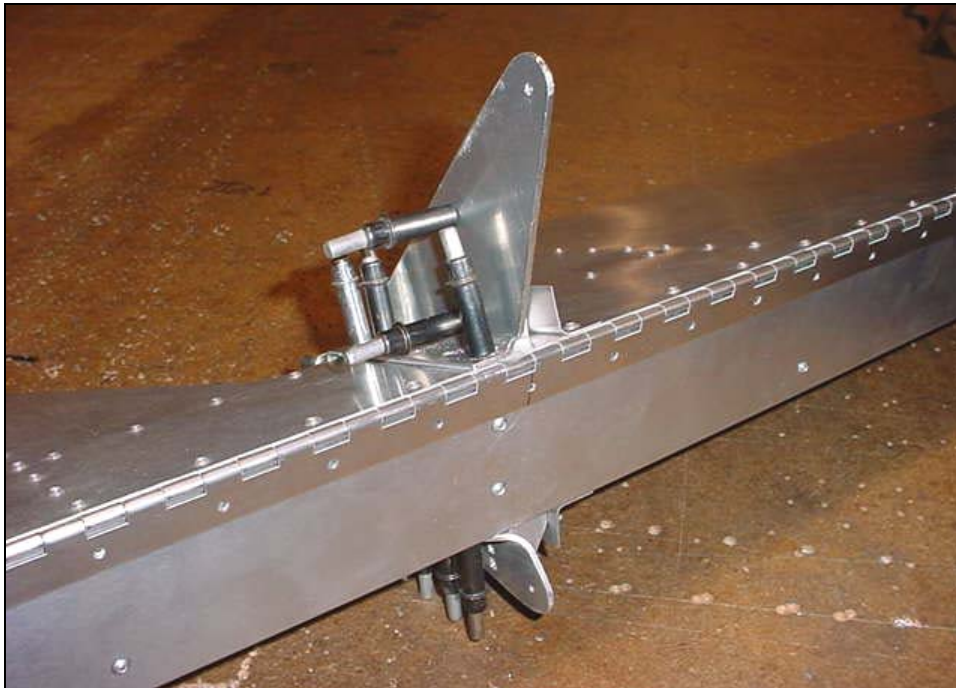
The side flange of the Angle 6T3-7 must be riveted to the Elevator Horn Doubler 6T3-6.

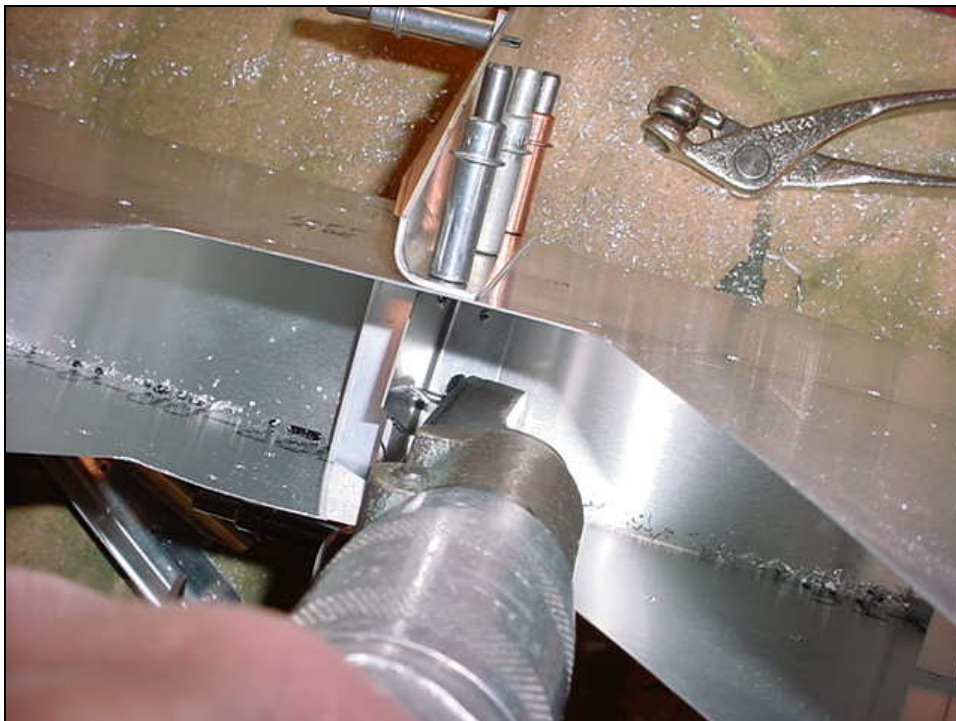
2 RIVETS A5
6T3-7 to 6T3-6

In this photo, the Channel 6T3-2 was removed to get in with an angle drill to drill.

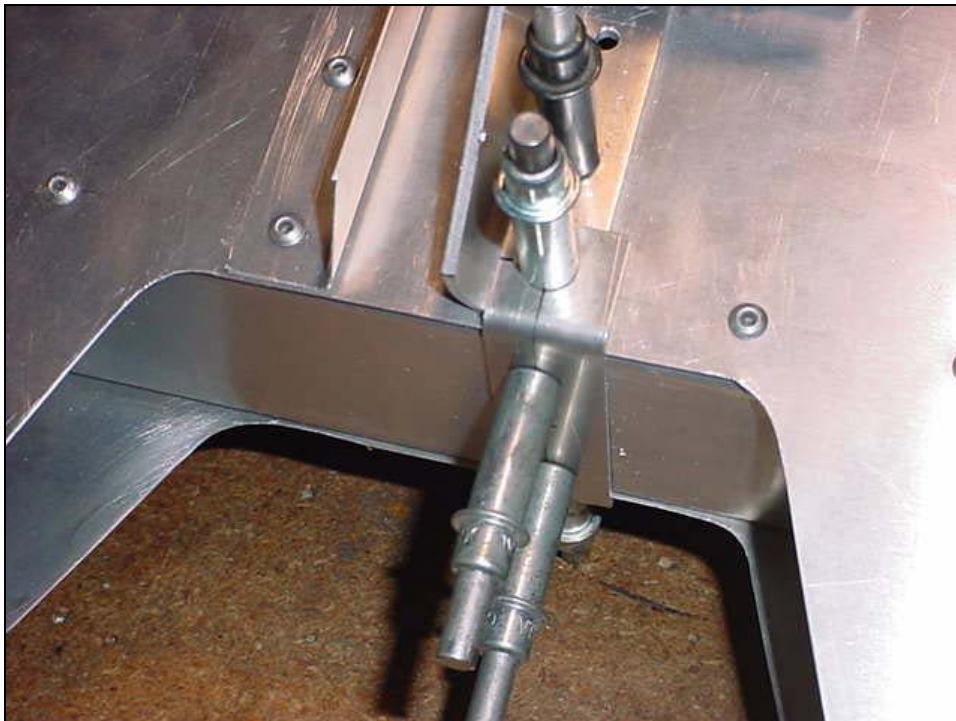
1 rivet AS5 through:
top flange 6T3-2, skin 6T3-3,
upper horns 6T3-4, strip 6T3-8.

1 rivet AS5 through:
bottom flange 6T3-2, skin
6T3-3, lower horns 6T3-5, strip
6T3-8.

1 stainless steel rivet through top and bottom flange of elevator center channel 6T3-2.

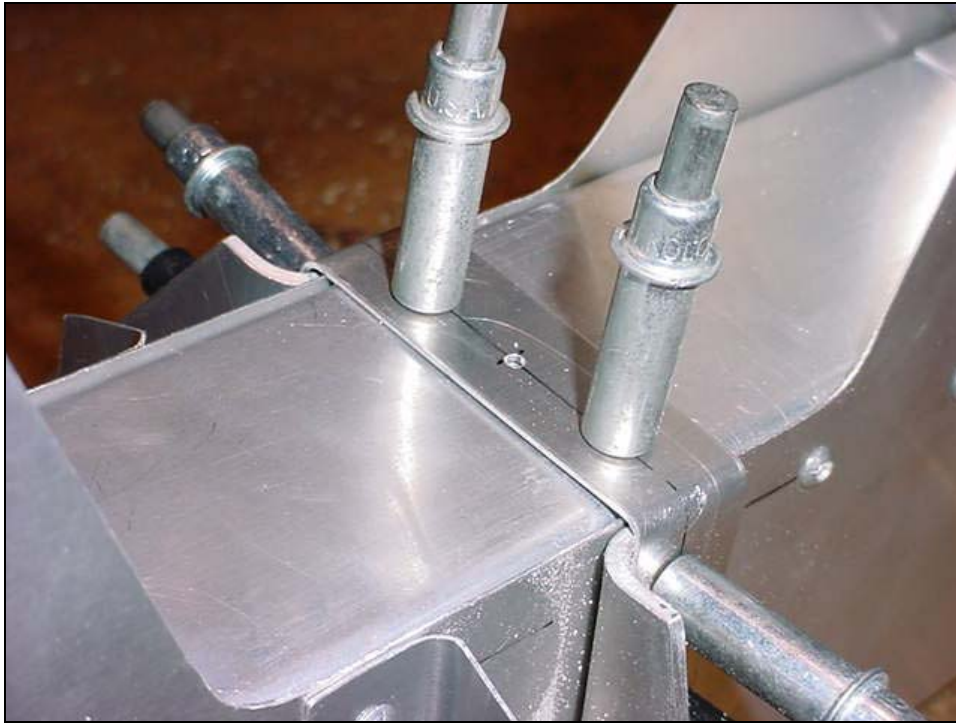
Detail of Bent Strip 6T3-8

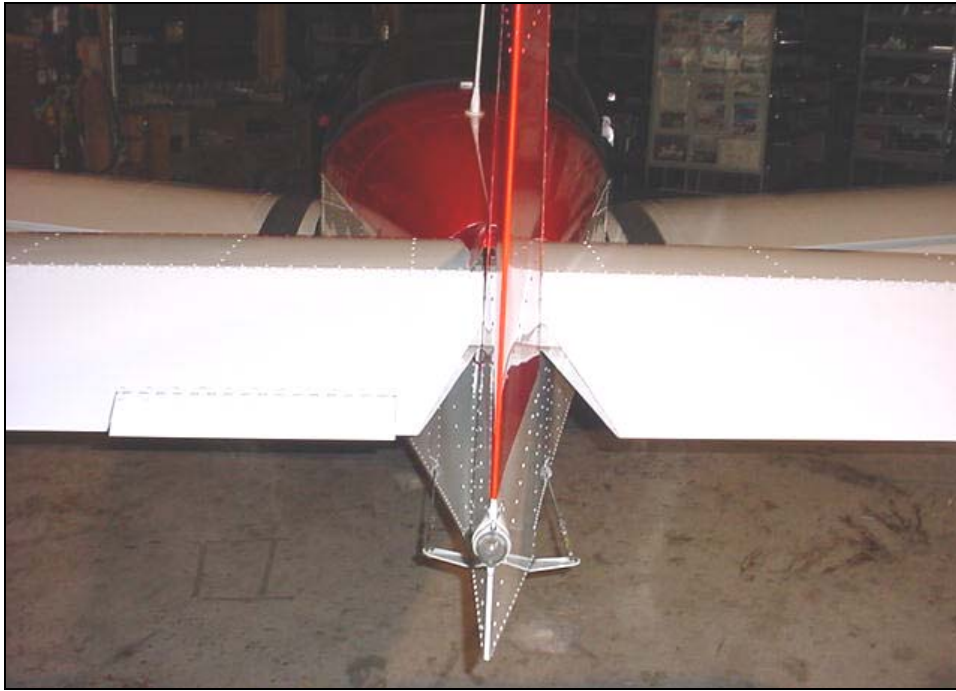
Rear view: elevator cutout to make room for the rudder deflections.

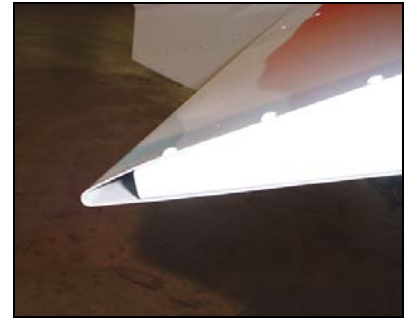
Gap between end of rib and trailing edge is generally left open.

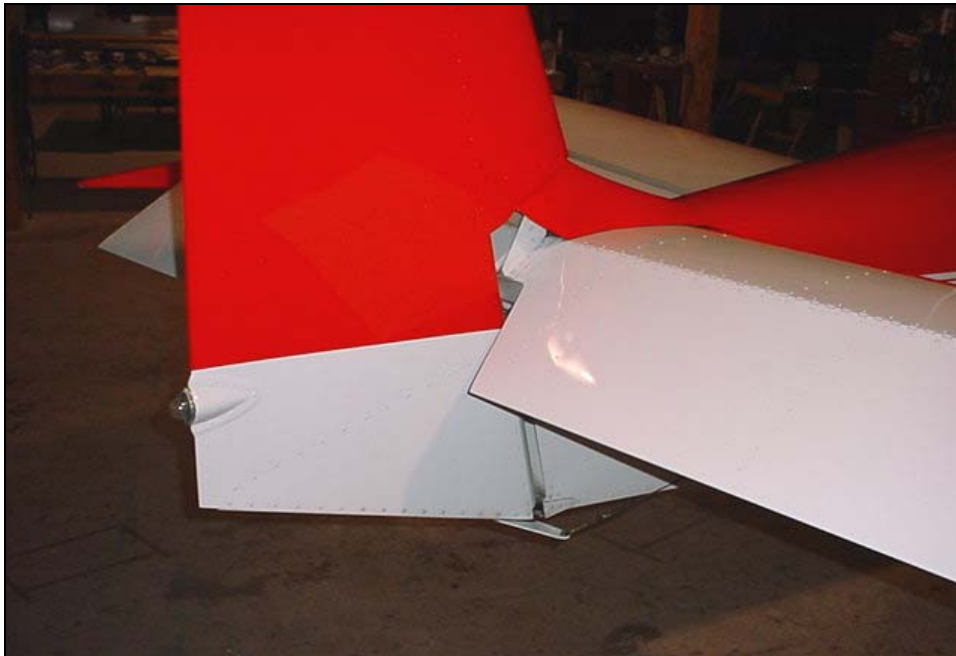
Gap between the skins around the rudder cutout is generally left open: with the rudder in place the gap is practically not visible!
